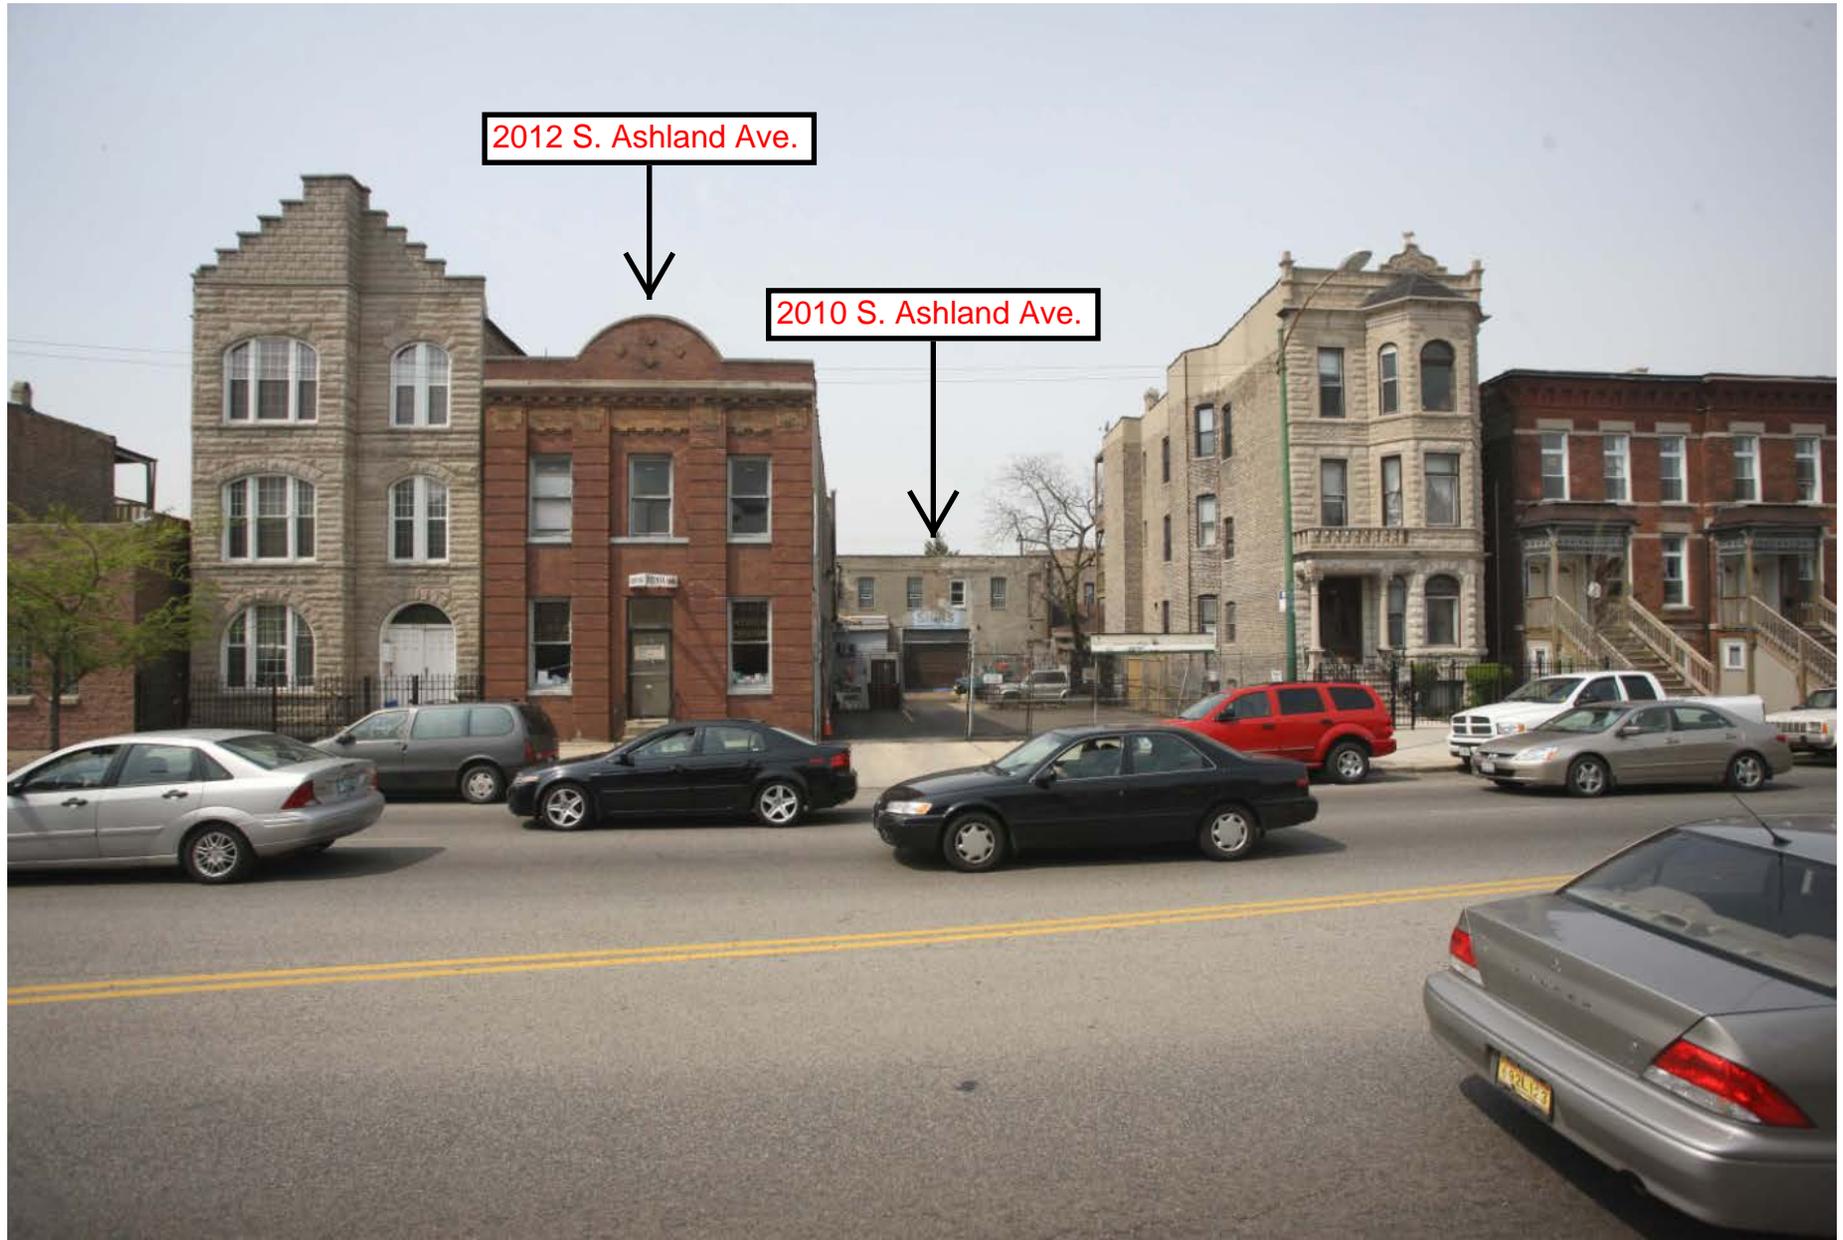
Photo 1 – Subject site and adjacent properties as seen from across S. Ashland Ave. looking west. Subject buildings identified by address. Photo courtesy of Cook County Assessor’s Office.

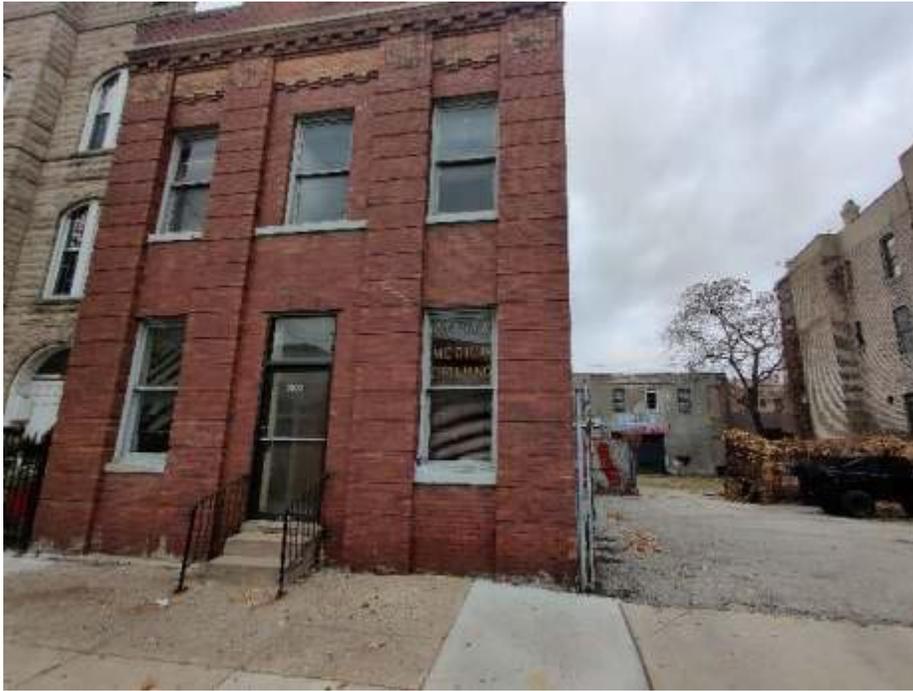
Photo 2 – Close up of 2012 S. Ashland Ave. with 2010 S. Ashland Ave. garage structure in the background and 2008 S. Ashland Ave. vacant lot in the foreground. Facing west. Photo courtesy of CDM Smith, Inc.

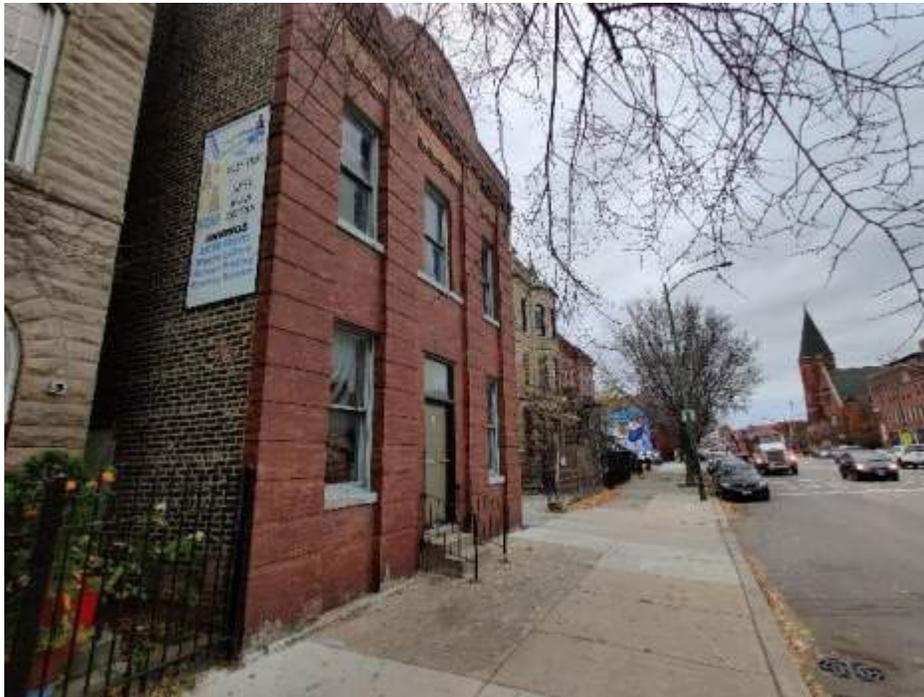
Photo 3 – Southeast corner of 2012 S. Ashland Ave. facing northwest along S. Ashland Ave. Photo courtesy of CDM Smith, Inc.

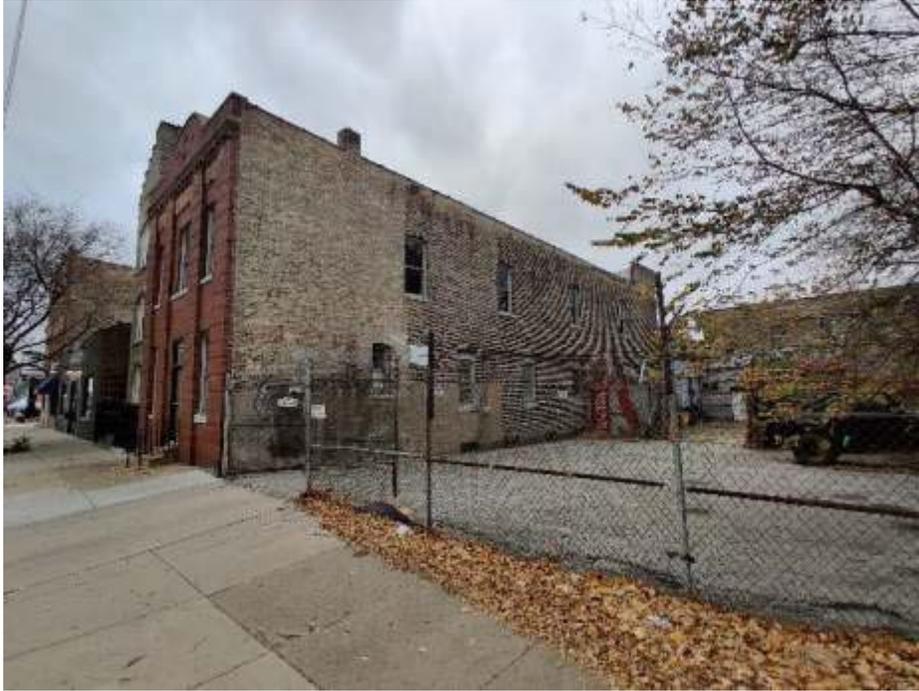
Photo 4 – Northeast corner of 2012 S. Ashland Ave. facing south west along S. Ashland Ave. Photo courtesy of CDM Smith, Inc.

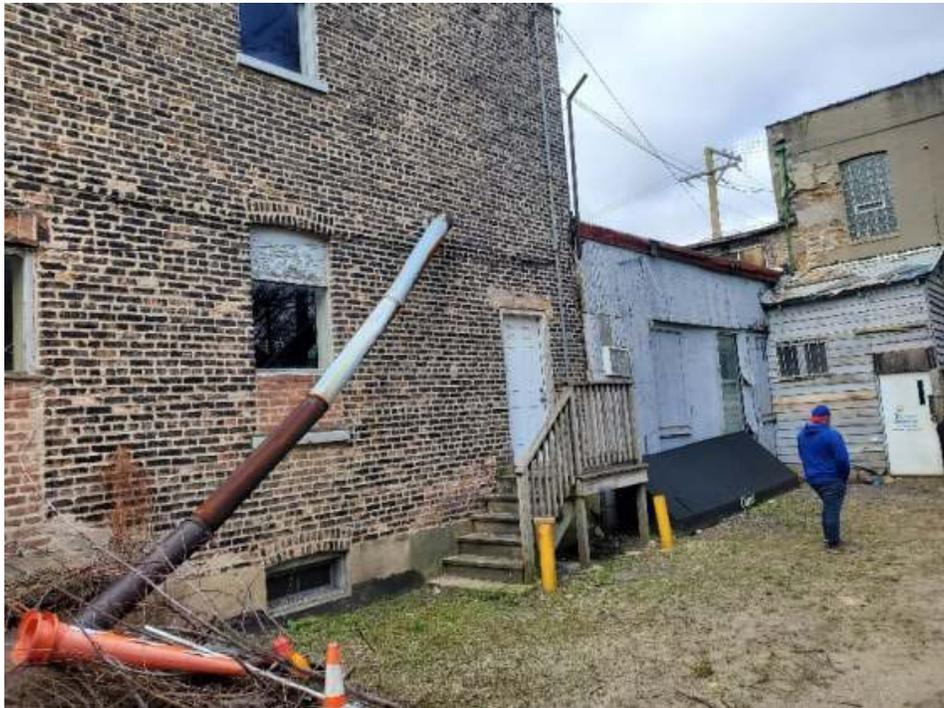
Photo 5 – View of the northern side of 2012 S. Ashland Ave. and the adjoining, single-story structure interconnected to 2010 S. Ashland Ave. Facing southwest. Photo courtesy of GSG Consultants, Inc.

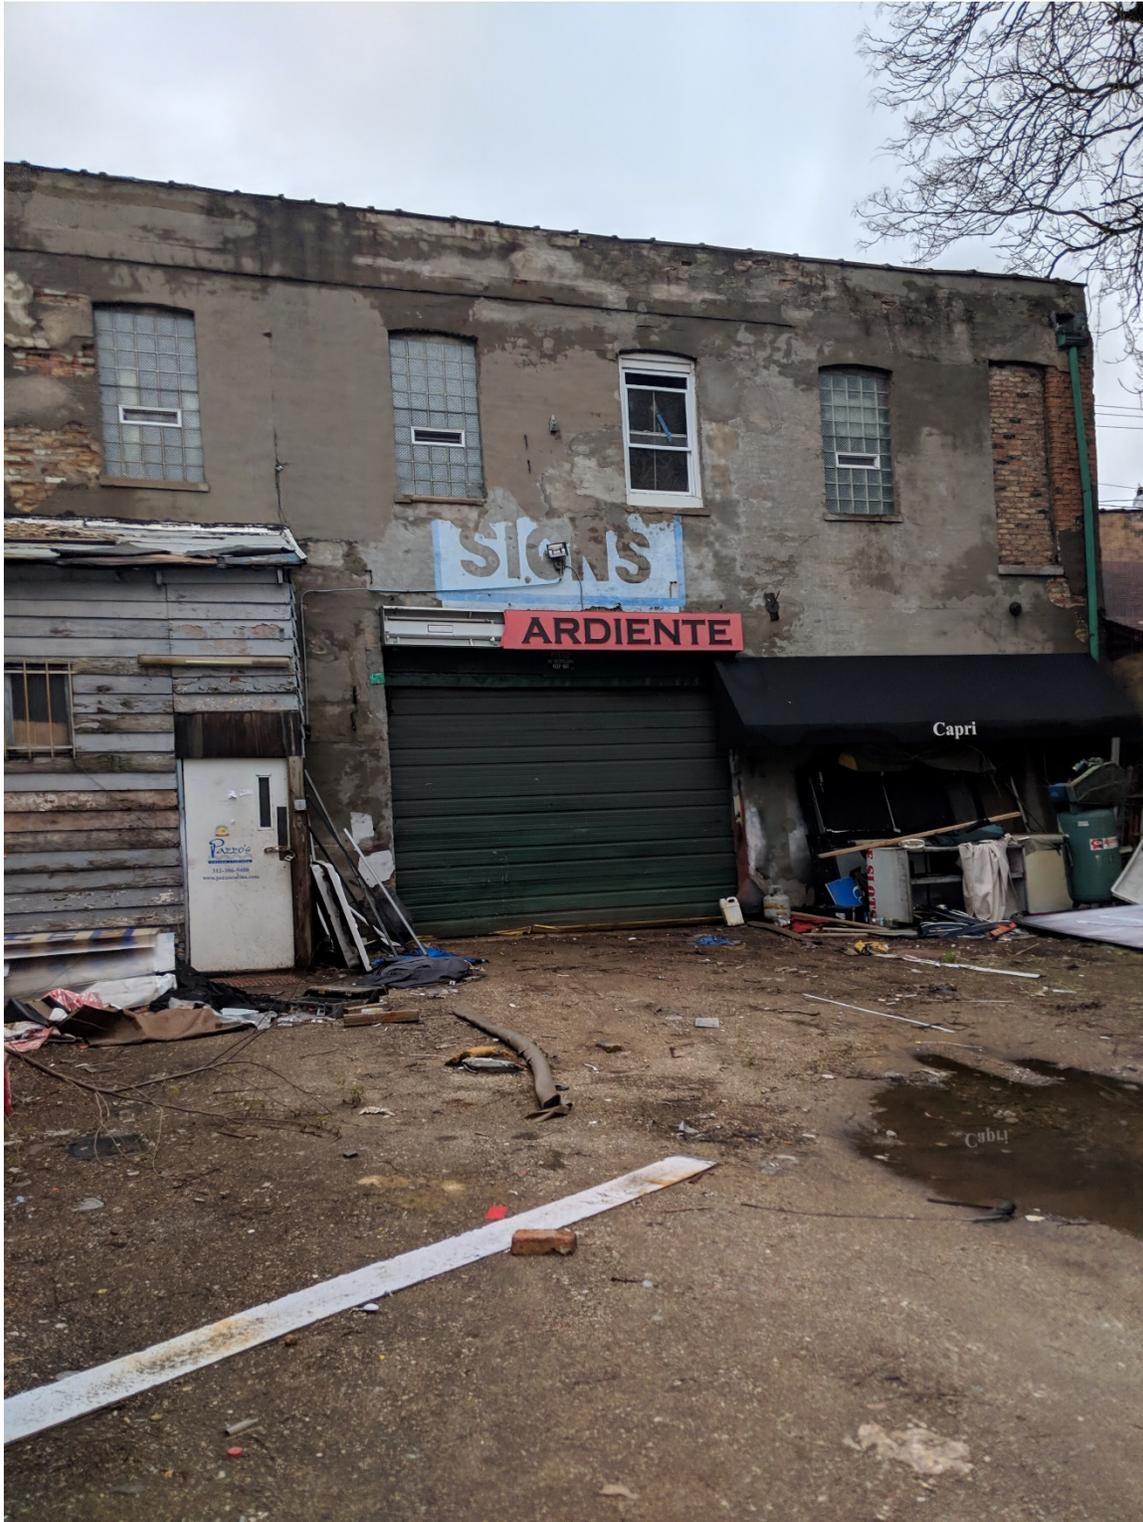
Photo 6 – View of 2010 S. Ashland Ave. garage structure facing west. Photo courtesy of The Resurrection Project.

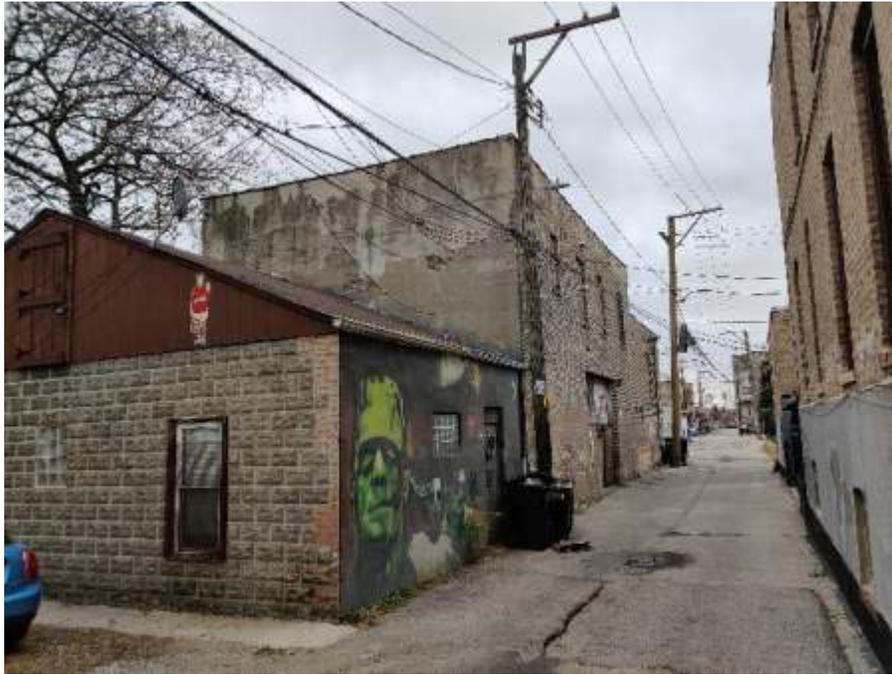
Photo 7 - Rear of 2010 S. Ashland Ave. garage structure along the alley, looking southeast from W. Cullerton St. Photo courtesy of CDM Smith, Inc.

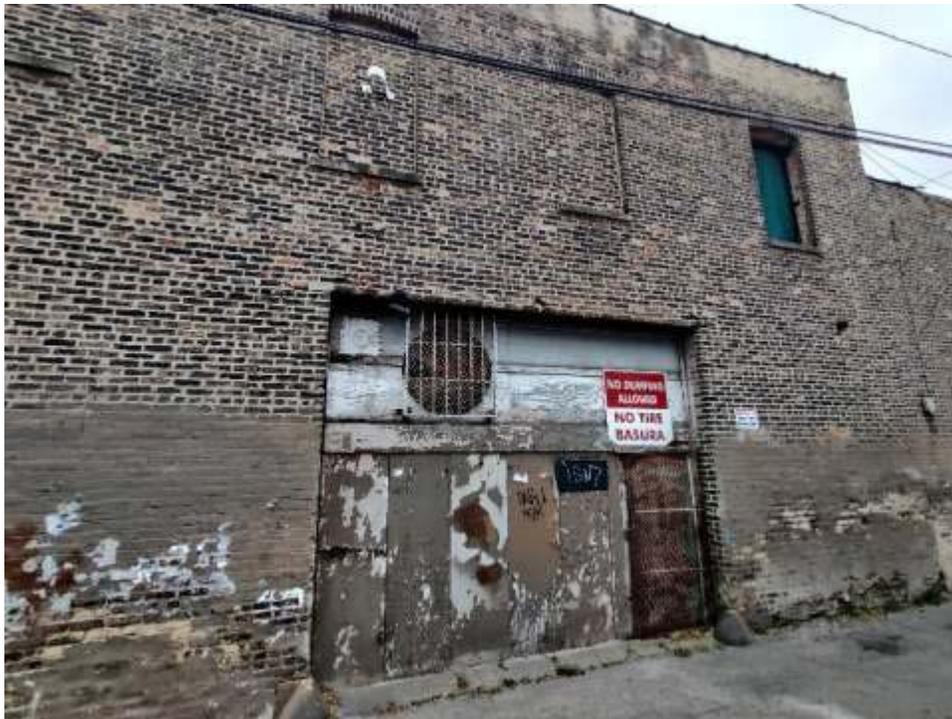
Photo 8 – Rear of 2010 S. Ashland Ave. garage structure along the alley, facing east. Photo courtesy of CDM Smith, Inc.

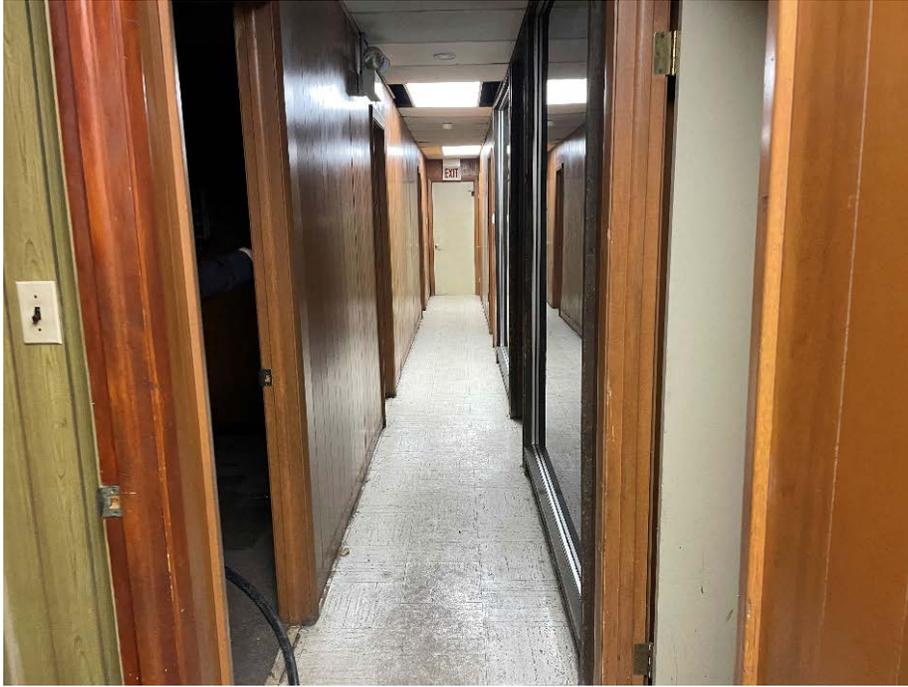
Photo 9 - View of the main corridor running east to west through the building. Photo taken facing west. Photo courtesy of GSG Consultants, Inc.

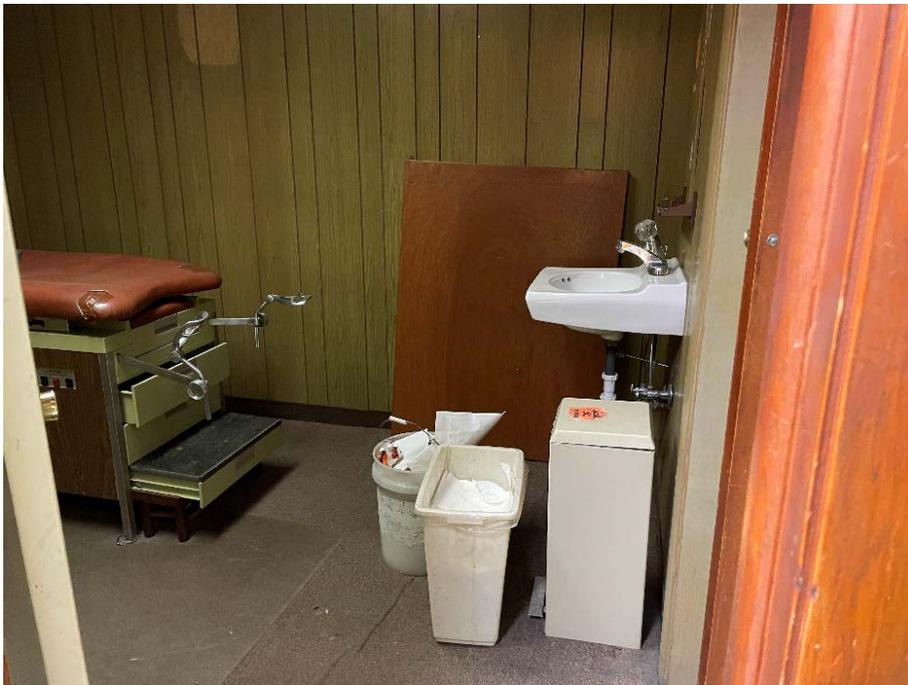
Photo 10 - View of one of the rooms on the east side of the main floor, previously utilized as an examination room. Photo taken facing southwest. Photo courtesy of GSG Consultants, Inc.

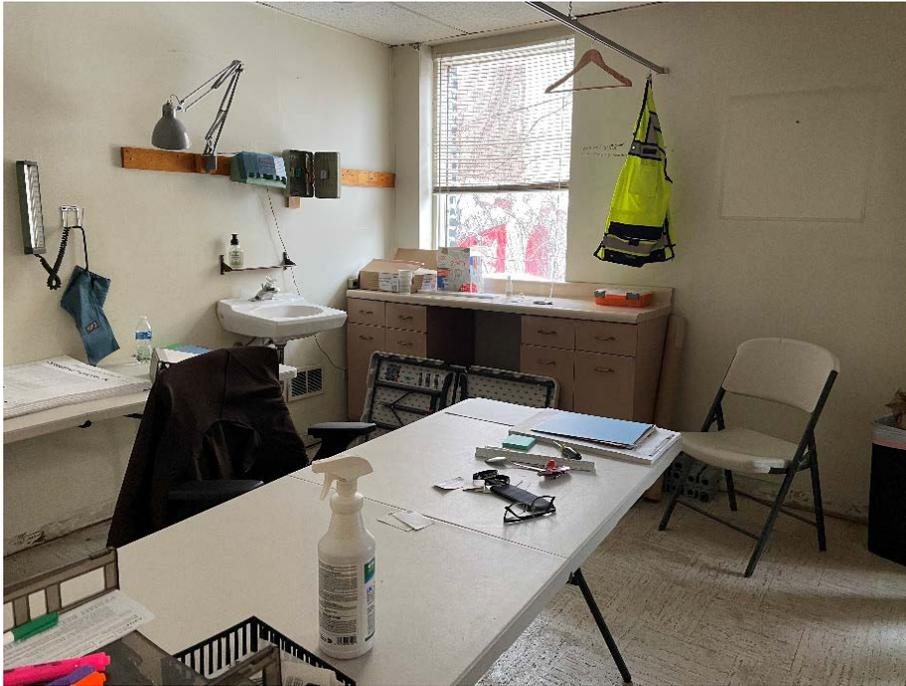
Photo 11 - View of one of the rooms on the north side of the main floor, currently being utilized as an office, facing northwest. Photo courtesy of GSG Consultants, Inc.

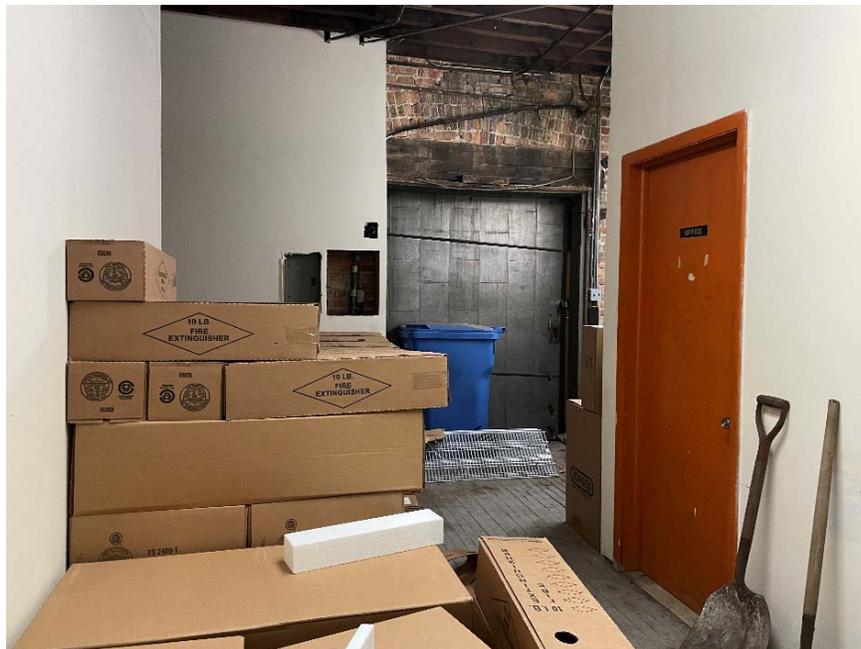
Photo 12 - View of the western most room on the main floor of the building with entry points to the basement, second floor and the second building on site, photo taken facing west. Photo courtesy of GSG Consultants, Inc.

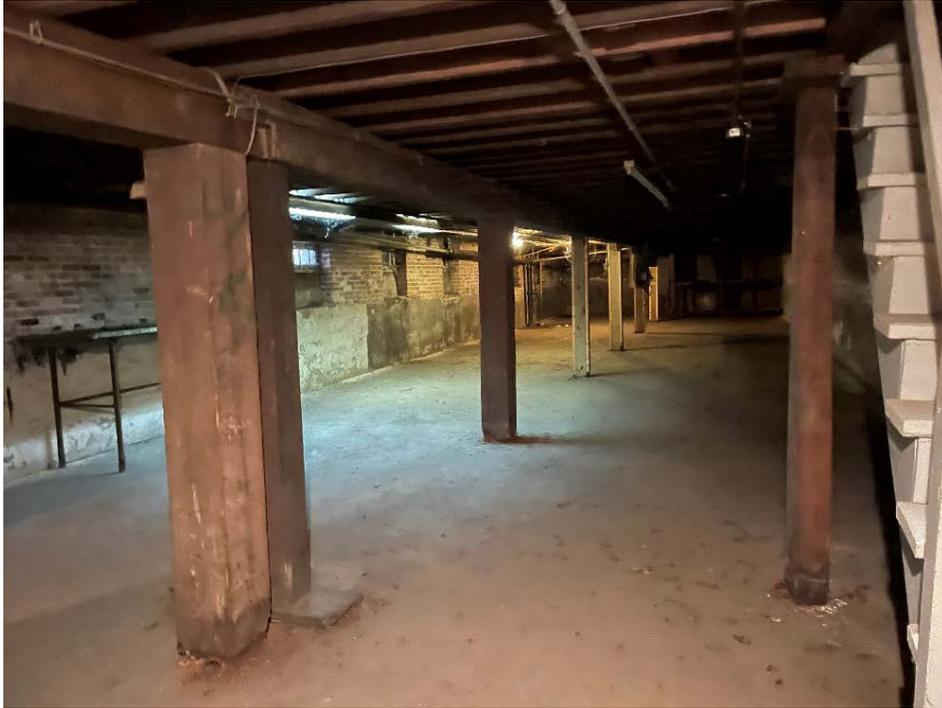
Photo 13 – View of the basement, facing east. Photo courtesy of GSG Consultants, Inc.

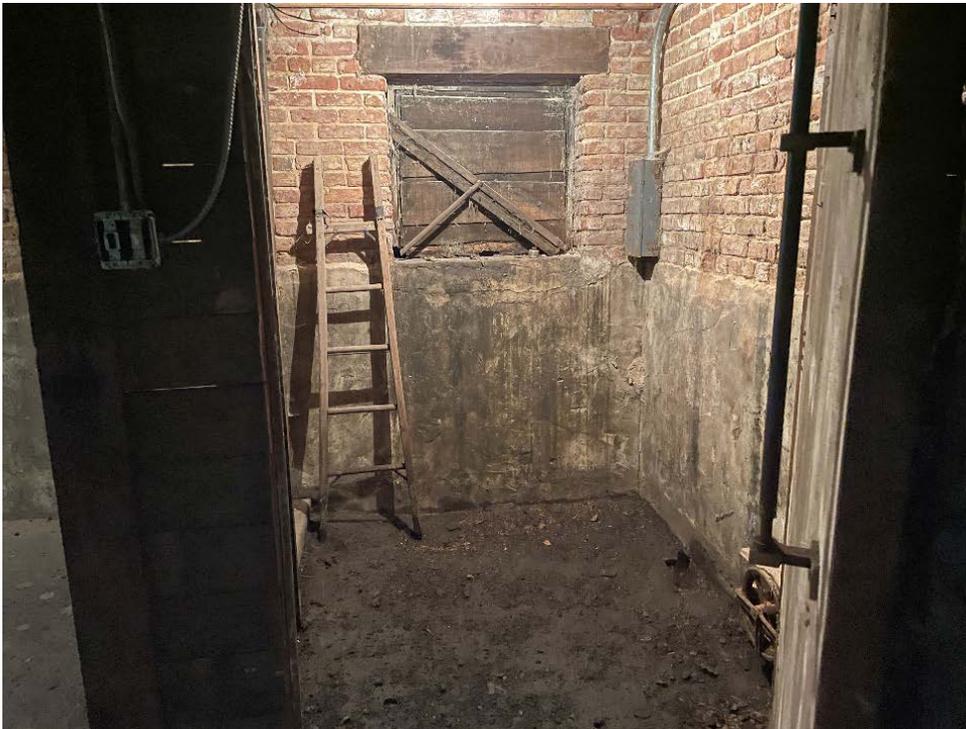
Photo 14 - View of the northwest corner of the basement, facing west. Photo courtesy of GSG Consultants, Inc.

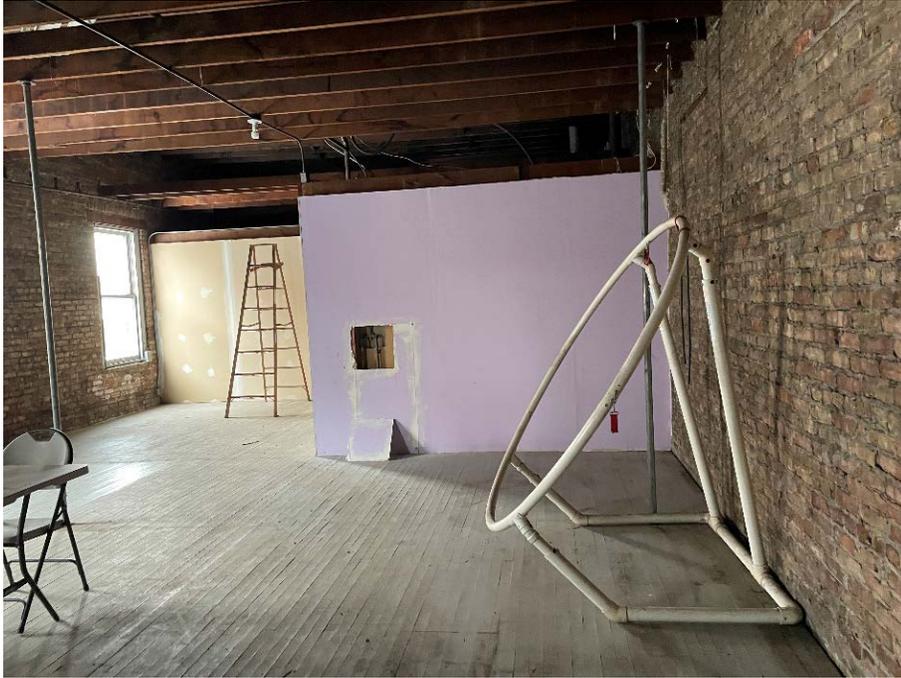
Photo 15 – View of the westernmost room on the second floor, facing east. Photo courtesy of GSG Consultants, Inc.

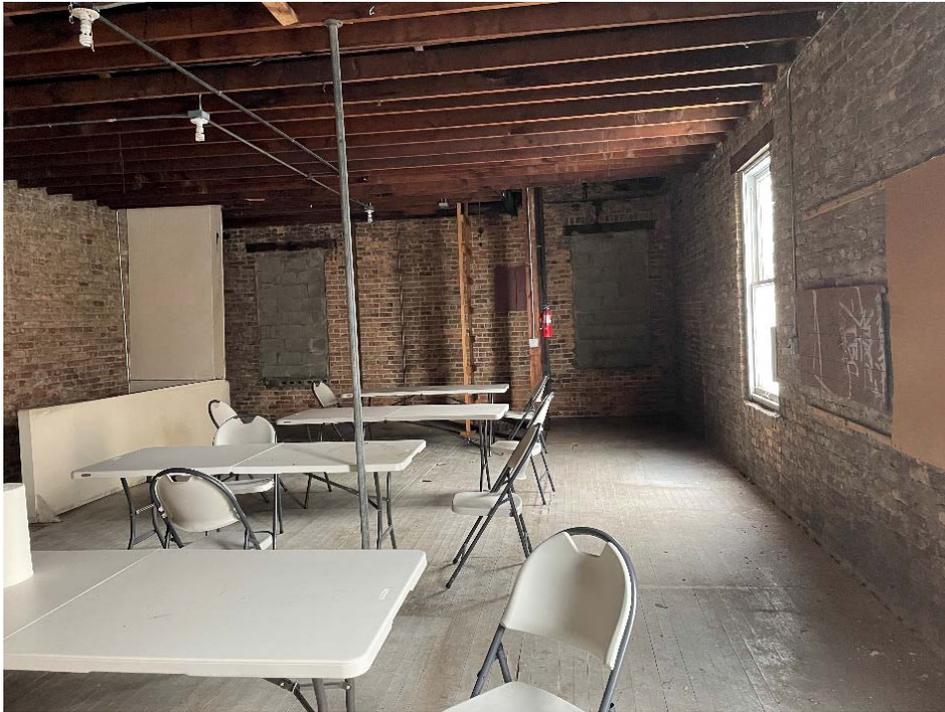
Photo 16 – View of the westernmost room on the second floor, facing west. Photo courtesy of GSG Consultants, Inc.

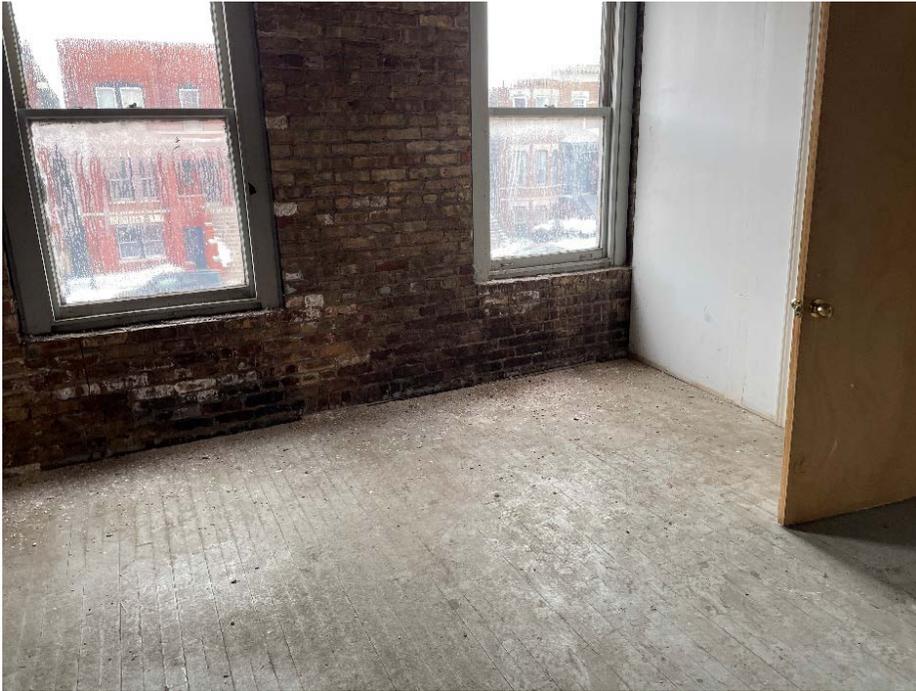
Photo 17 – Easternmost room on the second floor, facing southeast. Photo courtesy of GSG Consultants, Inc.

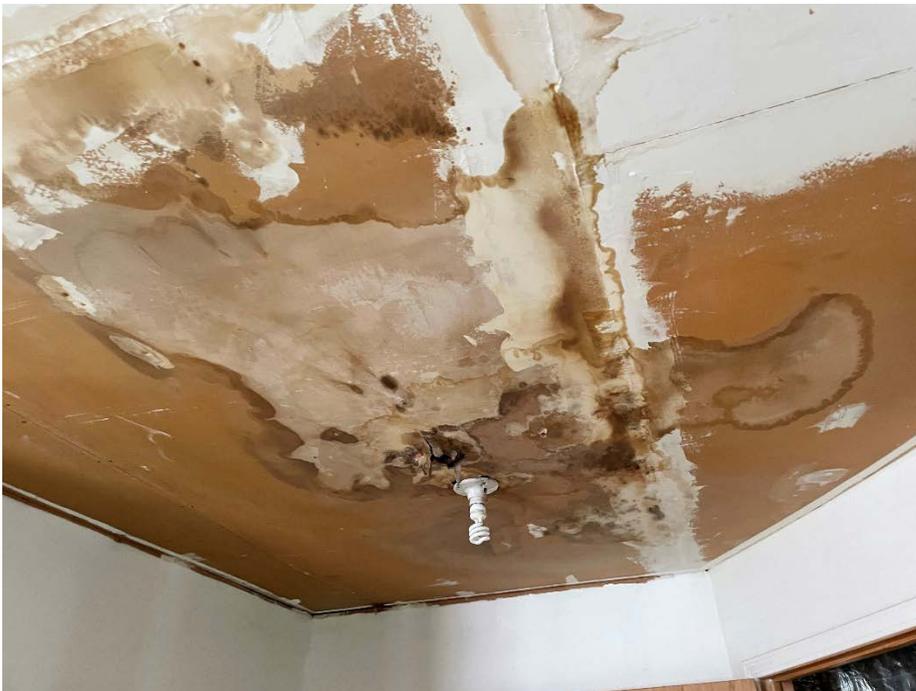
Photo 18 - Section of the second-floor ceiling, showing significant disrepair. Photo courtesy of GSG Consultants, Inc.

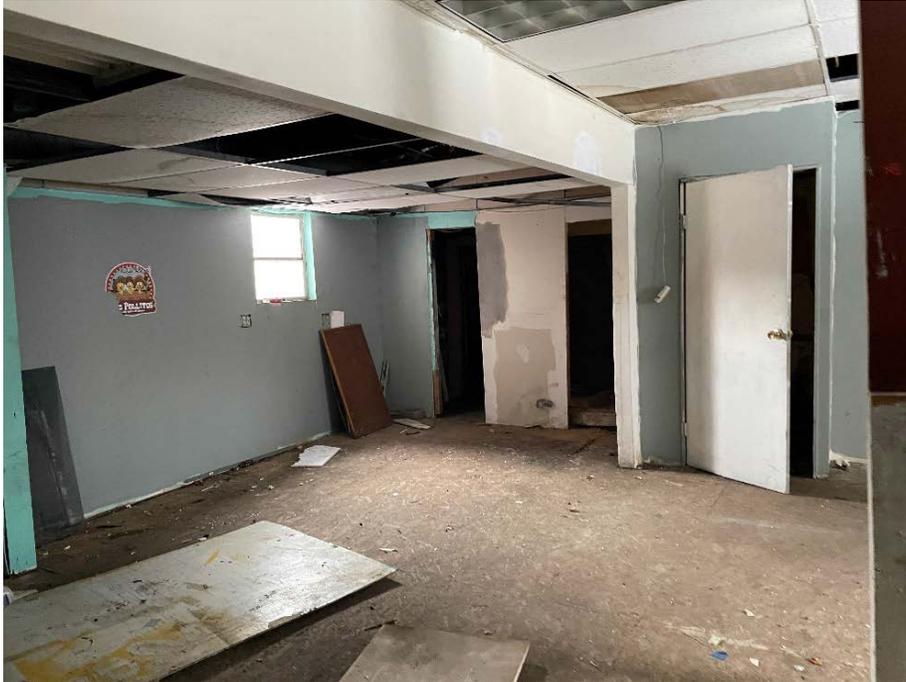
Photo 19 – Easternmost room in the second building, facing southwest. Photo courtesy of GSG Consultants, Inc.

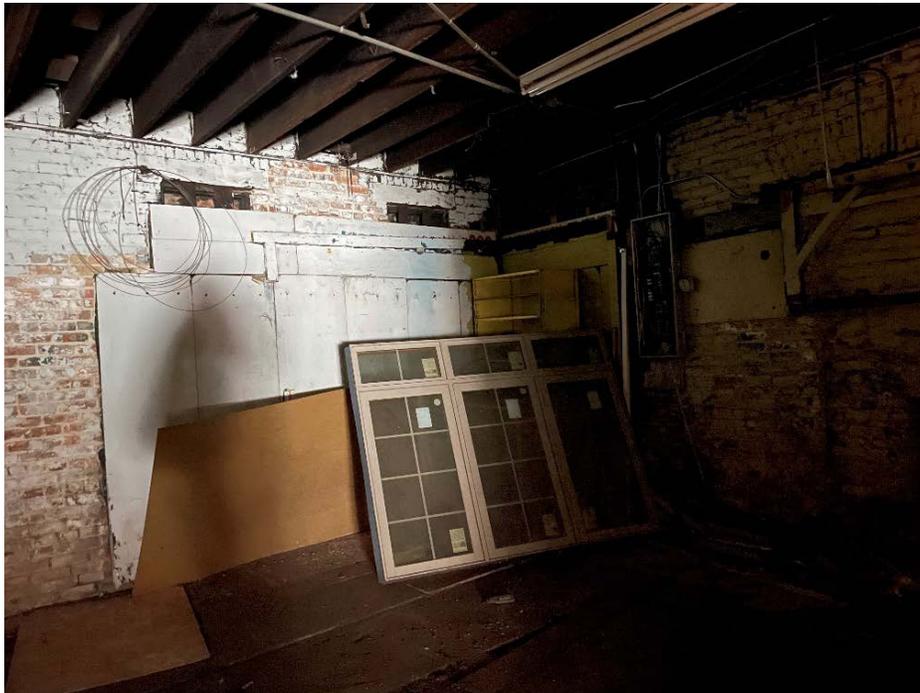
Photo 20 – Southernmost room in the second building, facing southwest. Photo courtesy of GSG Consultants, Inc.

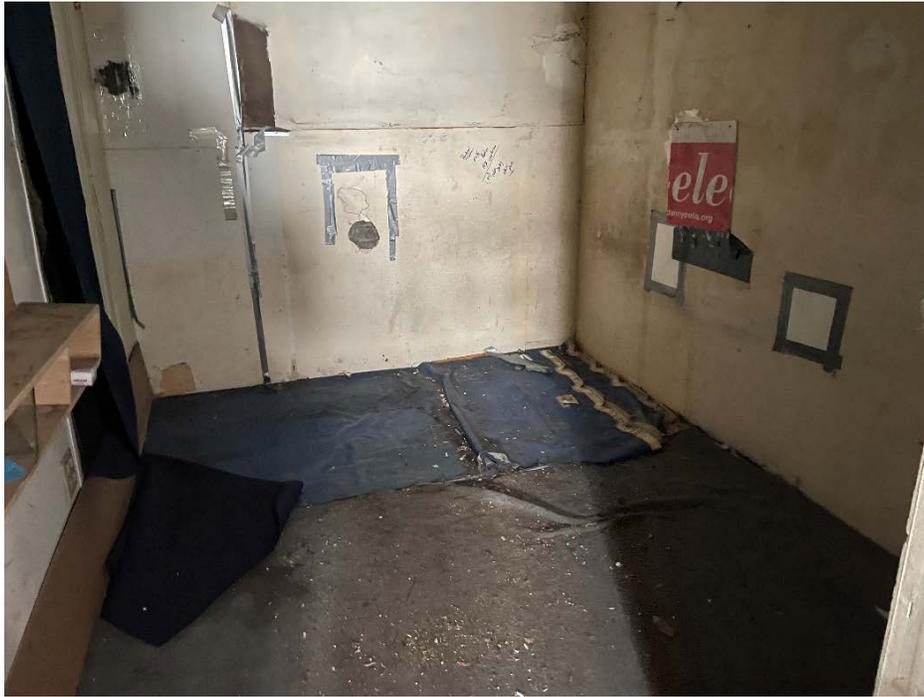
Photo 21 – Southernmost room on the second floor of the second building, facing east. Photo courtesy of GSG Consultants, Inc.

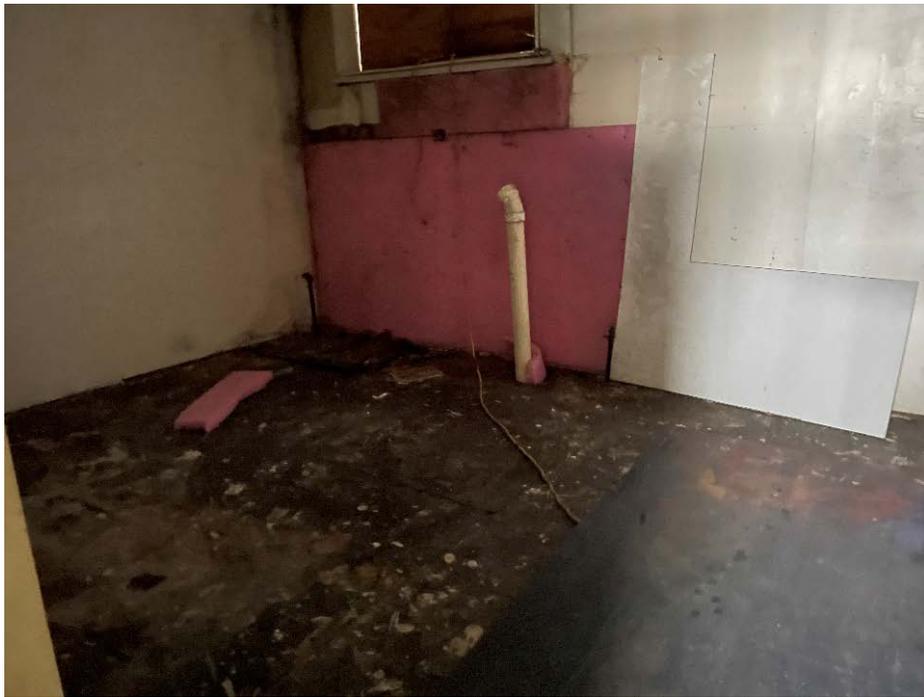
Photo 22 – Room situated on the east side of the second floor of the second building, facing northeast. Photo courtesy of GSG consultants, Inc.

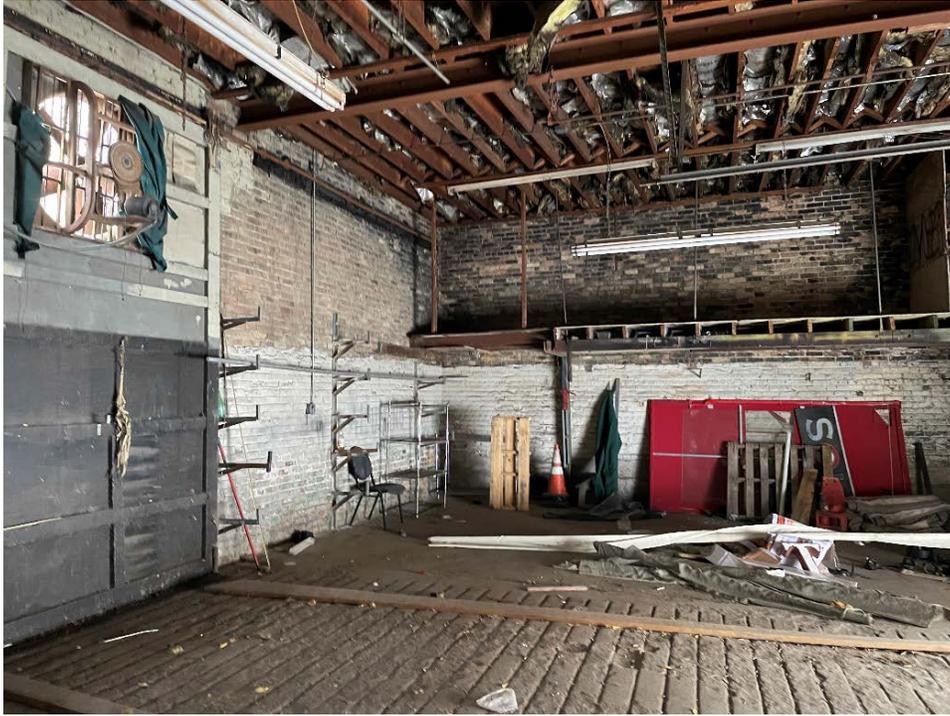
Photo 23 – Main floor of the garage (2010 S. Ashland Ave.) facing northwest. Photo courtesy of GSG Consultants, Inc.

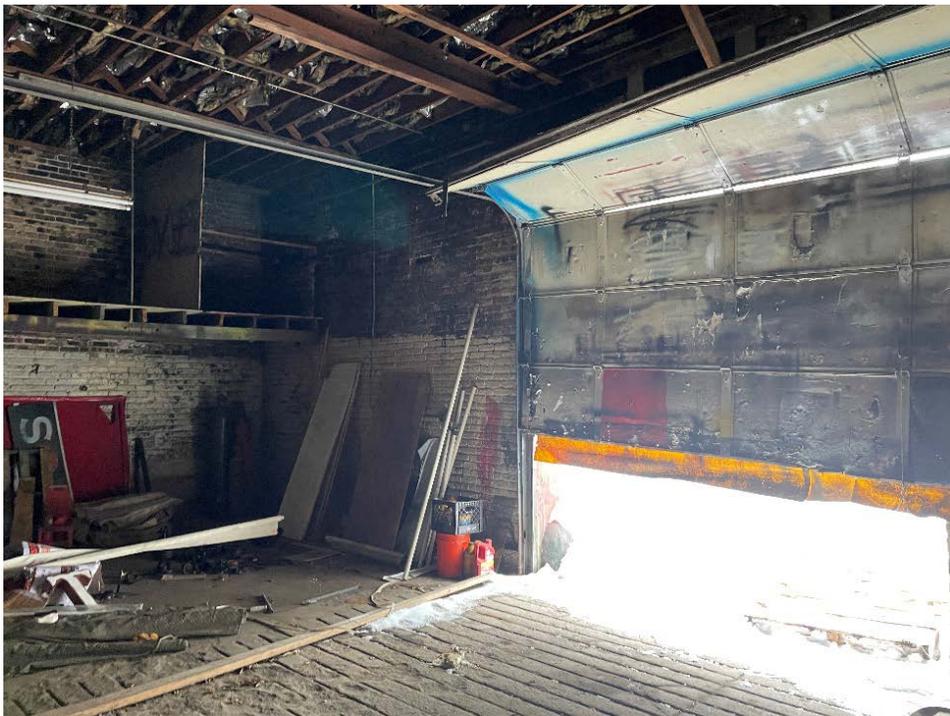
Photo 24 – Main floor of the garage facing northeast. Photo courtesy of GSG consultants, Inc.

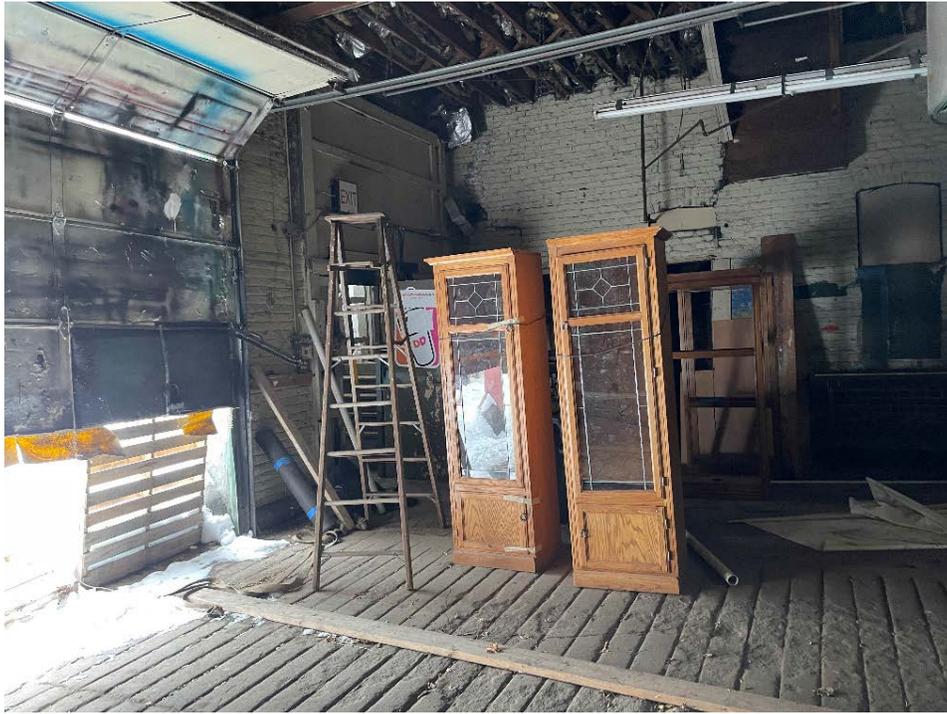
Photo 25 – Main floor of the garage facing southeast. Photo courtesy of GSG Consultants, Inc.

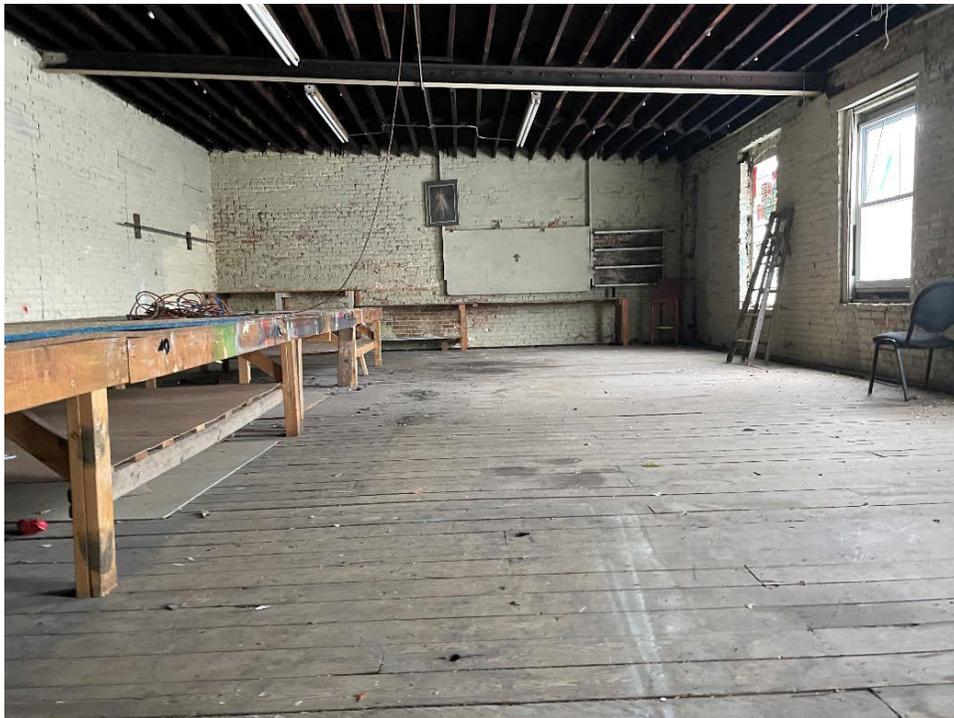
Photo 26 – Second floor of the garage facing north. Photo courtesy of GSG Consultants, Inc.

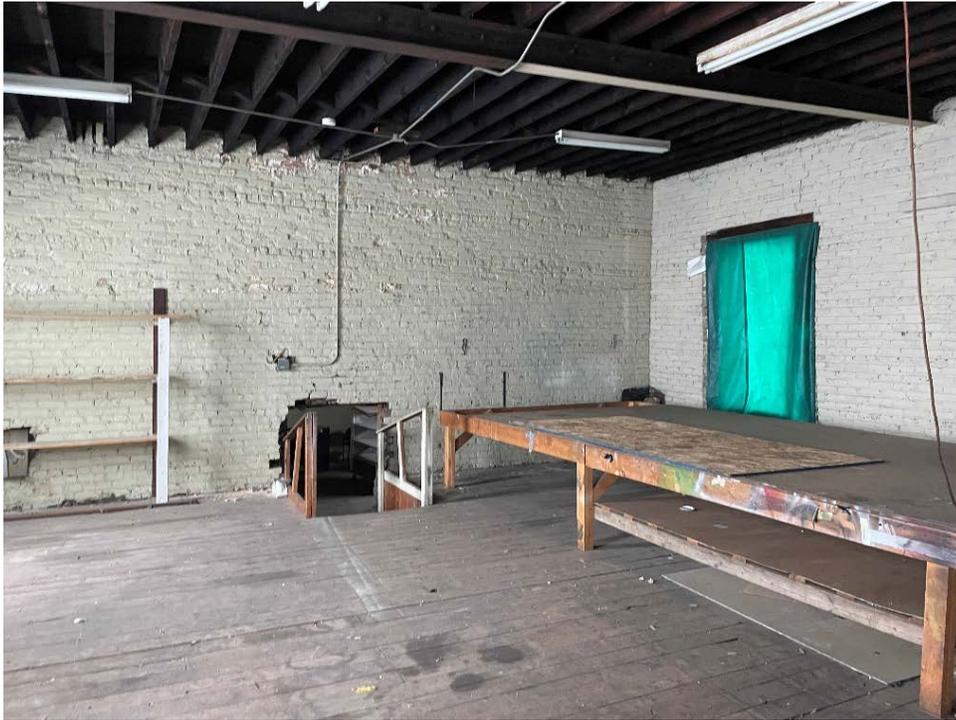
Photo 27 – Second floor of the garage facing southwest. Photo courtesy of GSG Consultants, Inc.
